# MH370 – Search and debris examination update

**ATSB Transport Safety Report**

AE-2014-054

2 November 2016

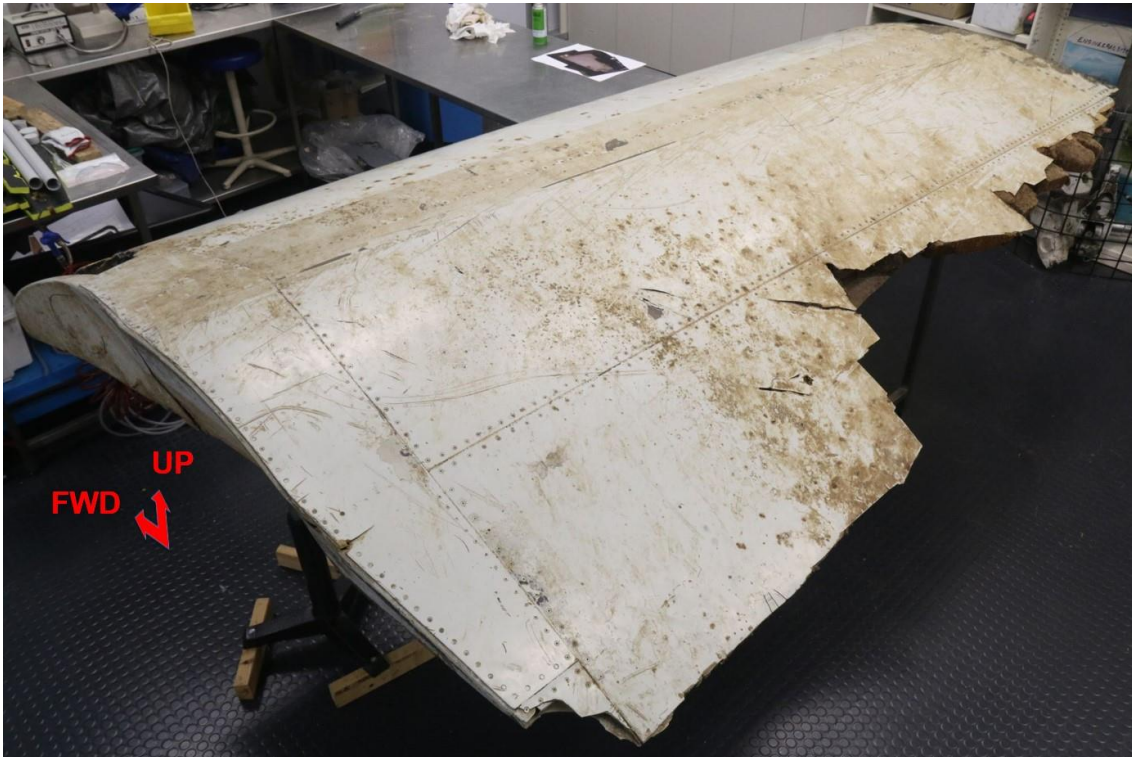
Figure 13: Inboard section of outboard flap

The recovered right, outboard wing flap section (Figures 12, 13 and 14) was examined for any evidence of interaction with mechanisms, supports and surrounding components that may indicate the state of flap operation at the time of fracture and separation from the wing. The purpose of the examination was to inform the end-of-flight scenarios being considered by the search team. The most significant items of evidence in relation to this are documented below.

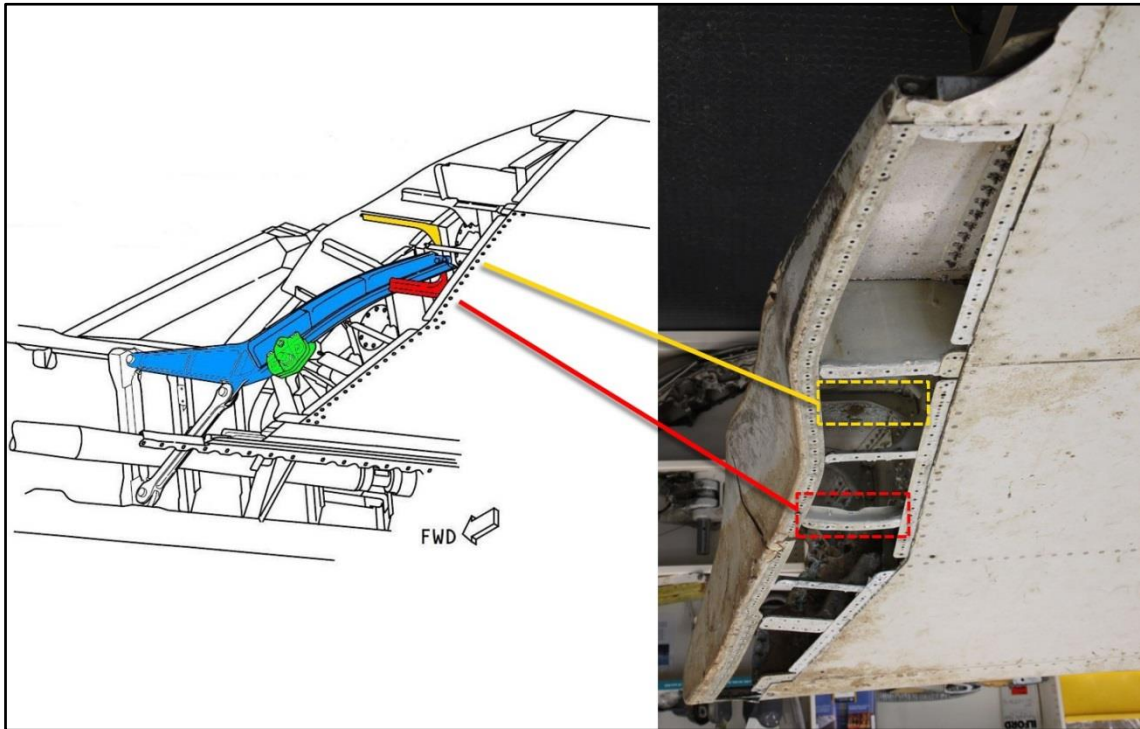
**Figure 16: Outboard flap location of damaged stiffeners within the seal pan cavity**

Two adjacent aluminium stiffeners within the inboard seal pan area exhibited impact damage. The damage was significant because it was indicative of impact damage and the only component in the vicinity of the stiffeners, capable of independent movement within the seal pan, was the support track. Measurements of the support track position at the various stages of flap deployment, indicated that the track would have to be fully inserted into the flap in the retracted position to be adjacent to the damaged stiffeners (Figures 16, 17 and 18).

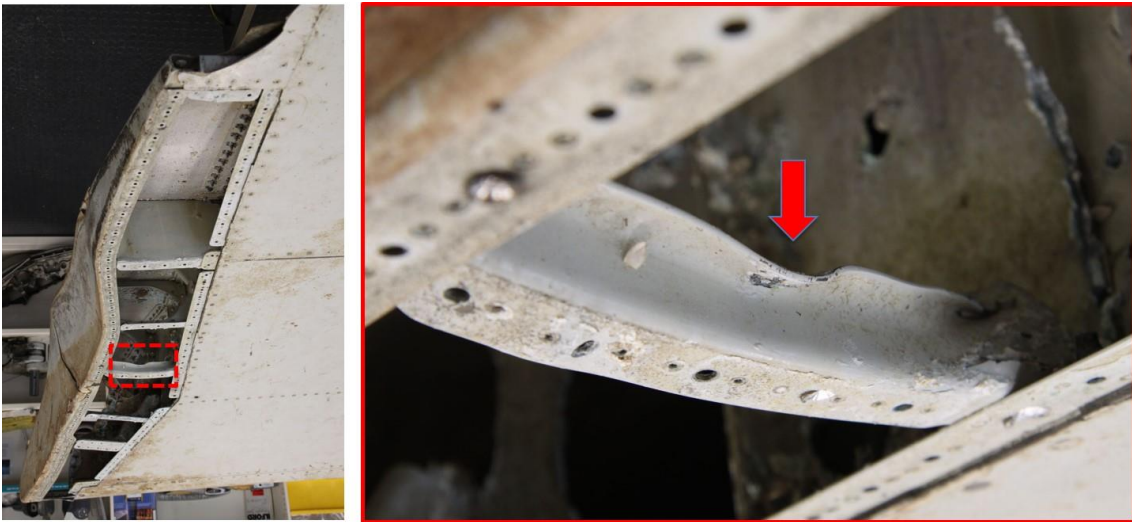
**Figure 17: Outboard flap, damaged stiffeners within the seal pan cavity**

Damage to the internal seal pan components at the inboard end of the outboard flap was possible with the auxiliary support track fully inserted into the flap. That damage was consistent with contact between the support track and flap, with the flap in the retracted position. The possibility of the damage originating from a more complex failure sequence, commencing with the flaps extended, was considered much less likely.

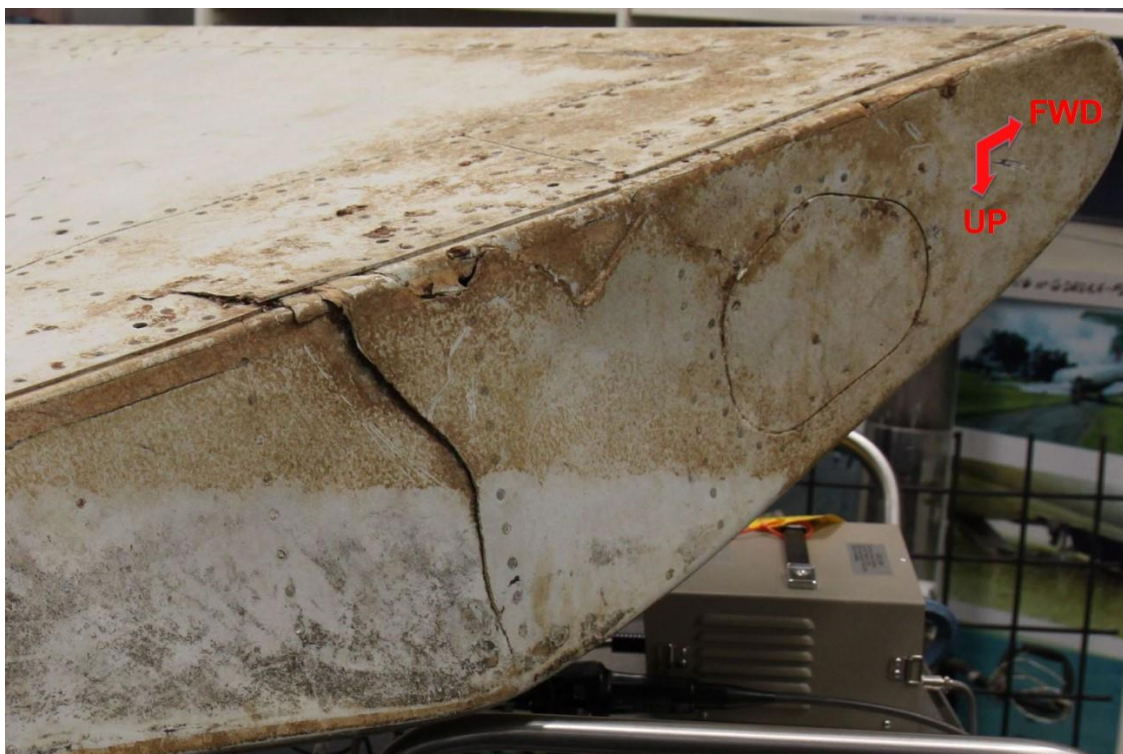
**Figure 19: Outboard flap, fractured seal pan (forward)**

An outwards-fracture of the fibreglass seal pan initiated at a location adjacent to the damaged aluminium stiffeners (Figure 19). The damage was most likely also caused by impact from the support track. That damage provided further evidence of the support track position within the flap seal pan cavity, indicating that the flaps were retracted at the point of fracture and separation from the wing.

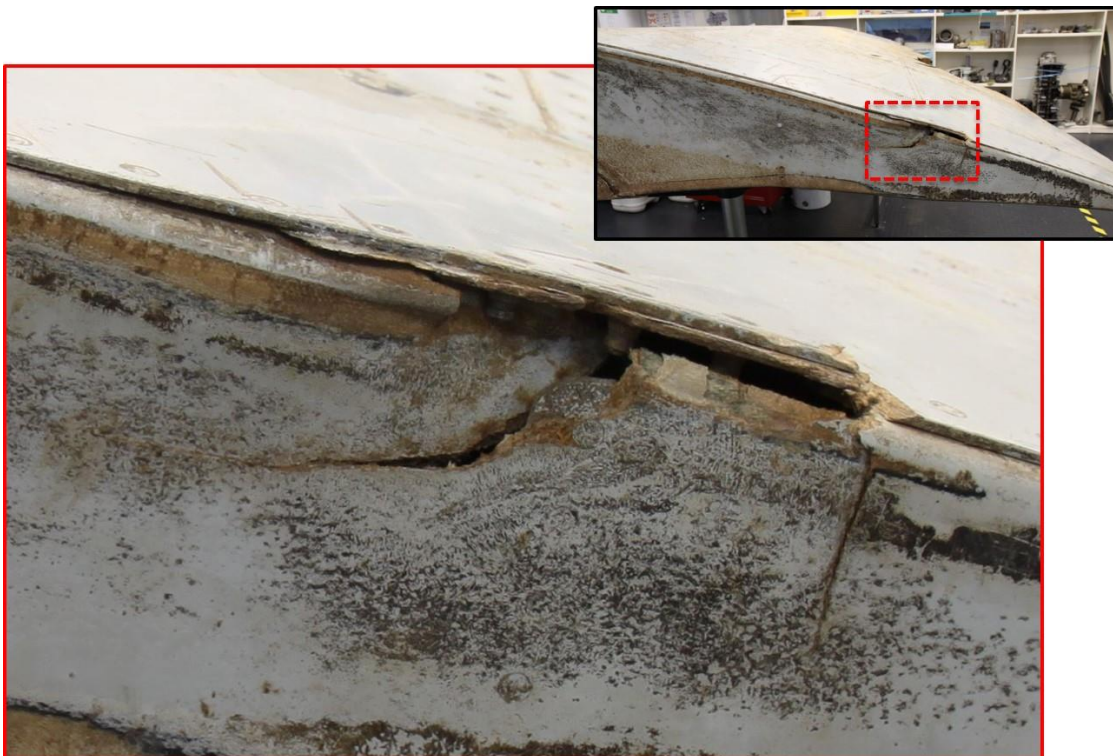
Figure 20: Outboard flap, fractured seal pan (aft)

The flap seal pan was also fractured adjacent to the rear spar. The fracture resulted from external impact, puncturing the fibreglass and plastically deforming the supporting aluminium structure within the seal pan cavity (Figure 20). Comparable damage was noted at the outboard, rear spar and surrounding structure of the adjacent flaperon (Figure 21). It was noted that the two areas in question are aligned when the flaps are in the retracted position, with a significant offset existing at other stages of flap extension (Figure 22).

With the flap in the retracted position, alignment of the flap and flaperon rear spar lines, along with the close proximity of the two parts, indicated a probable relationship between two areas of damage around the rear spars of the parts. This was consistent with contact between the two parts during the aircraft breakup sequence, indicating that the flaperon was probably aligned with the flap, at or close to the neutral (faired) position.
